NBSIR 73-105

Environmental Evaluation of Polyurethane Foam Core Sandwich Panel Construction

Final Report

Prepared for
Office of Research and Technology
Department of Housing and Urban Development
Washington, D. C. 20410

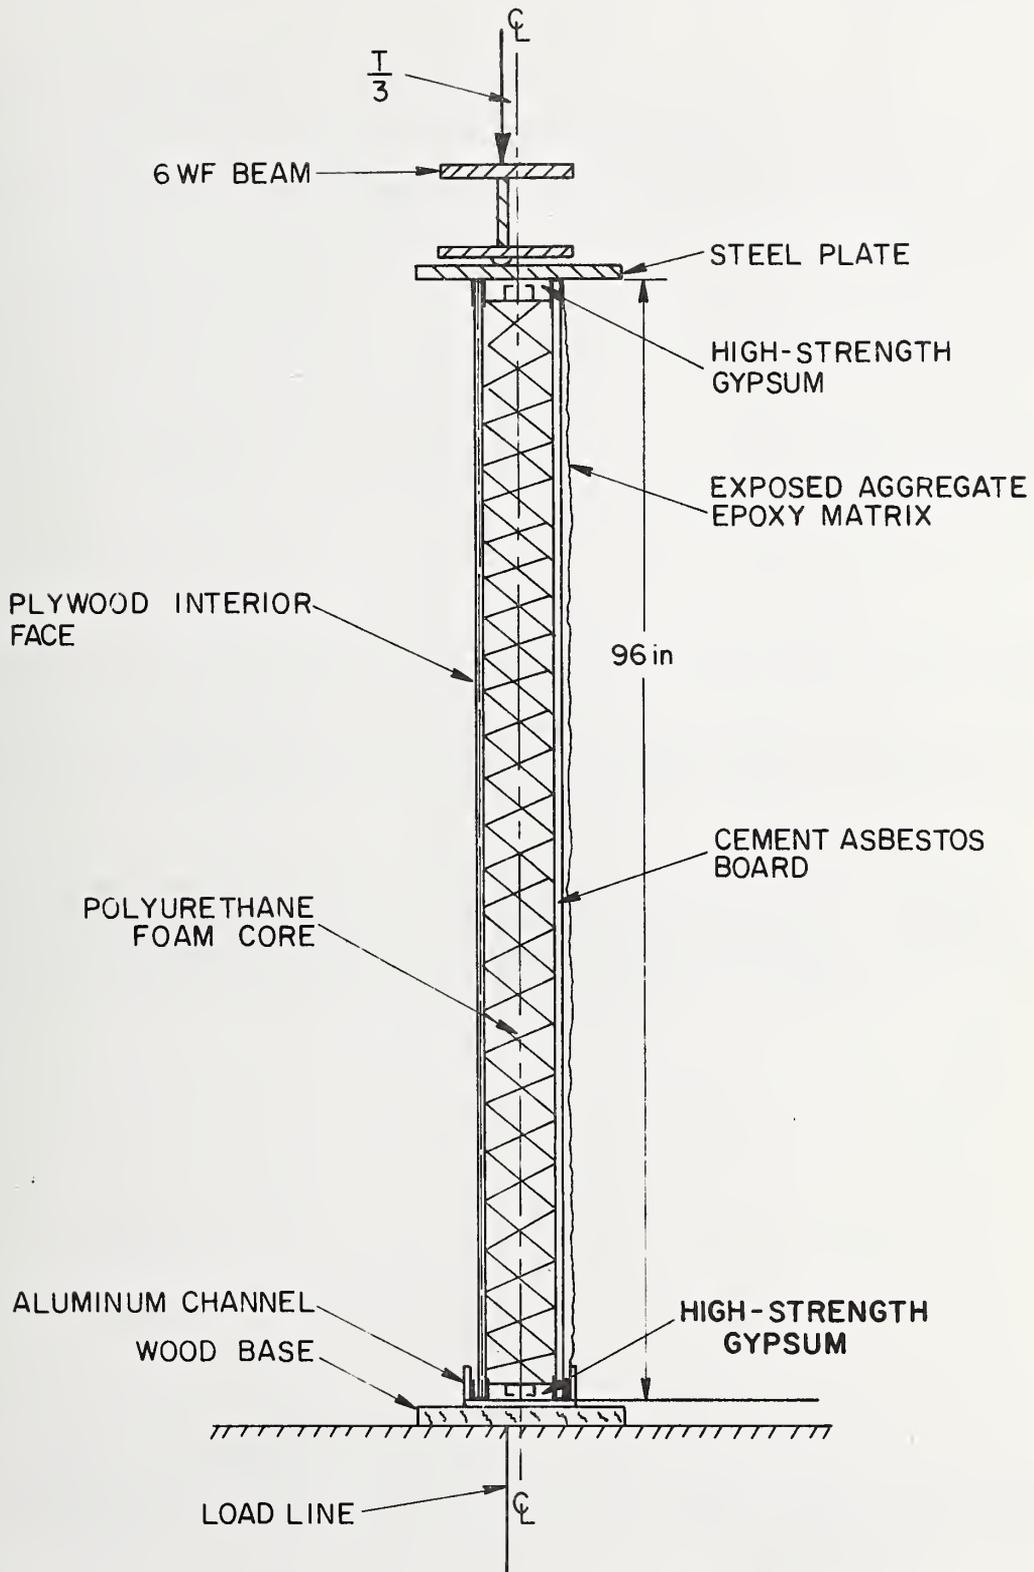
T = PANEL THICKNESS

FIGURE 25. SCHEMATIC FOR SHORT-TERM COMPRESSION TEST ON FULL SIZE WALL PANEL

Both panels used in the environmental test were subjected to a short-term compressive test using simulated in-service end conditions. The length of each test specimen was 96-in. To prevent the crushing of the aluminum extrusions at each end of the panel and to insure a uniform bearing surface, both ends of each test specimen were embedded in a high-strength plaster. One end of the panel was set in a 1-3/4-in deep by 3-in wide by 48-in long aluminum channel. The channel was attached to a 2 x 8 x 48-in wood base which in turn was bearing on the platen of the hydraulic testing machine. The rotational restraint produced by this test condition at the bottom of the panel is probably greater than that which the panel would experience in the actual structure. The load was applied to the top of the wall through a 2 x 6 x 48-in steel plate. The load was applied to this plate through a 6-in wide flange beam and a 3/4-in half-round steel rod along a line of action offset from the center of the panel 1/3 of the panel thickness to the inside face as indicated in figure 25. This end condition allowed for some end rotation and a load eccentricity that the top of the wall might experience in service.

A 250 lb load was applied to the panel and maintained for a short time in order to "seat" the specimen in the test fixture. Load was then continuously applied at a rate of approximately 5000 lb per minute up to the point of no further increase. The specimen was allowed to deform as the load decreased until half of the maximum load remained. The specimen was then unloaded.
